Rehabilitation Solution for Old Transformers

Failure of Power Transformer during operation in customer network.

Rating: 40 MVA Three winding
Voltage: 6.6/13.8/132 Kv
Manf. Year: 1982
End User: Saudi Electricity Co. , Makkah area

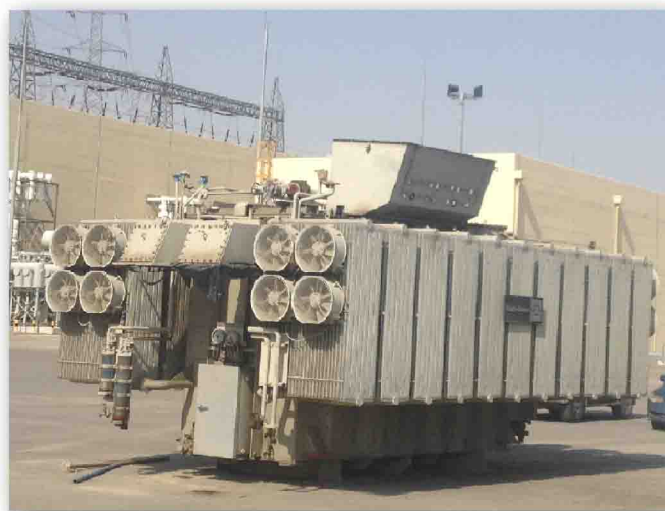
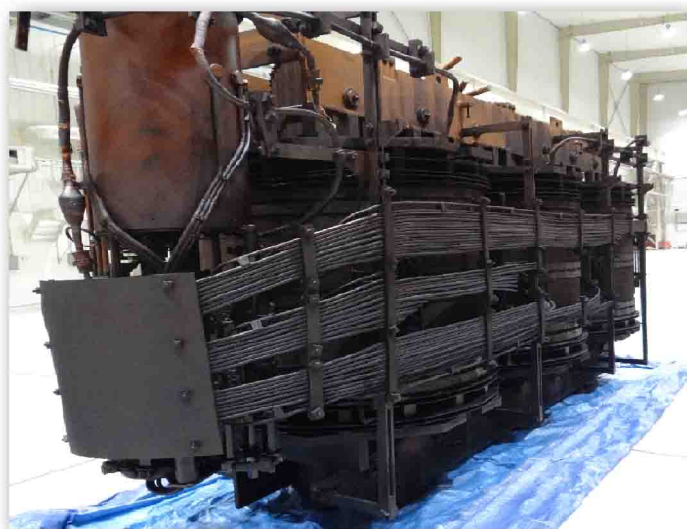
- After investigation it was observed that winding was severely damaged with heavy carbon deposits on insulation and in the oil.
- The cause of the problem is major arcing happened inside the winding due to degradation & ageing of insulation (32 years).
- Tap changer parts require replacement however tap changer model is obsolete.

Design a new complete active Parts “winding, core, and tap changer” that fit inside existing tank, with all existing auxiliaries
